TASK 1. PRESENCE/ABSENCE SURVEYS, WATER TEMPERATURE, STREAM FLOW AND LAGOON MONITORING OF SANTA MONICA MOUNTAINS CREEKS

SANTA MONICA BAY ANADROMOUS ADULT AND JUVENILE STEELHEAD MONITORING 2013-2018

Prepared for CDFW contract No P1250013

May 2018

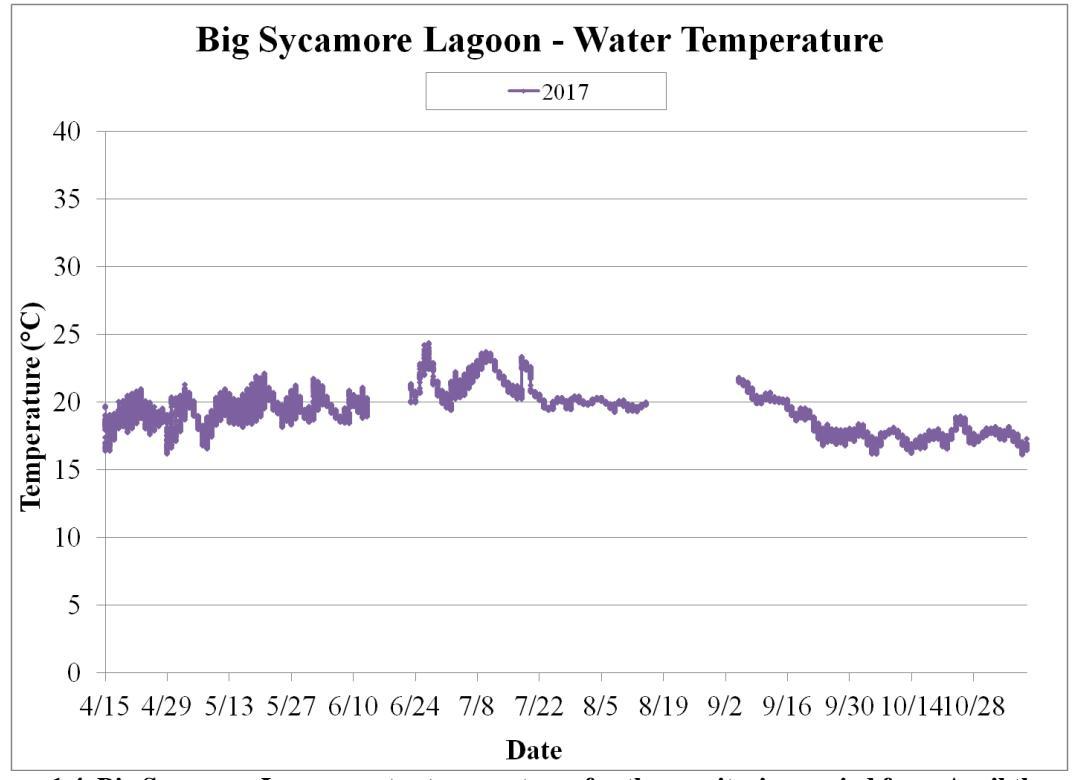
Figure 1.4. Big Sycamore Lagoon water temperatures for the monitoring period from April through November of 2017

Continuously recording thermometers were not deployed in the lagoon or at any upstream site between 2013-2016 due to lack of water. A HOBO was deployed from 14 April–9 November 2017 just upstream of the pedestrian bridge. Further details on the data are found in Appendix 1C.

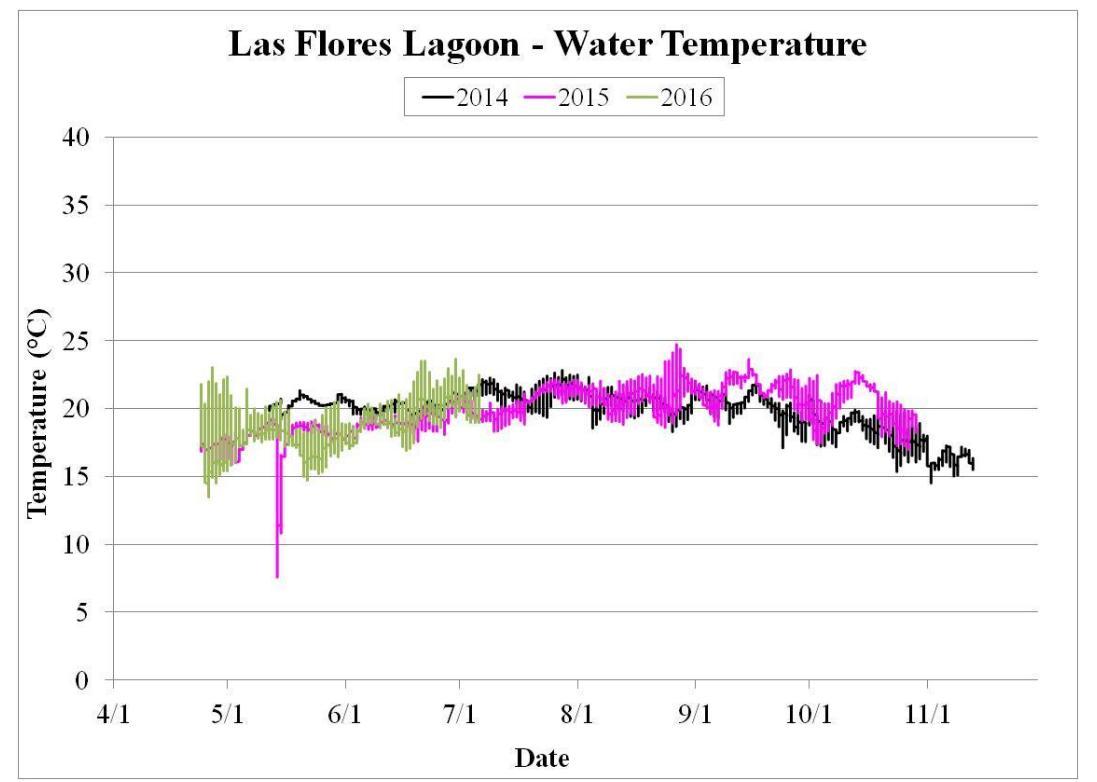
Figure 1.6. Las Flores Lagoon water temperatures for the monitoring period from April through November of 2014 - 2016

Figures 1.5-1.9 illustrate the continuous temperature patterns in 2014 and 2015. Overall water temperatures were slightly higher in 2015 and the water level in the lagoon slightly lower. Figure 1.10 illustrates the proportion of time at each temperature. In 2014, temperatures were often between 18.5-21 °C, but in 2015 there was a shift to more time at temperatures above 21 °C. As shown in Figure 1.10 temperatures exceeded 23 °C for several hours in August 2015. This is considered to be the threshold for temperatures supporting *O. mykiss*.

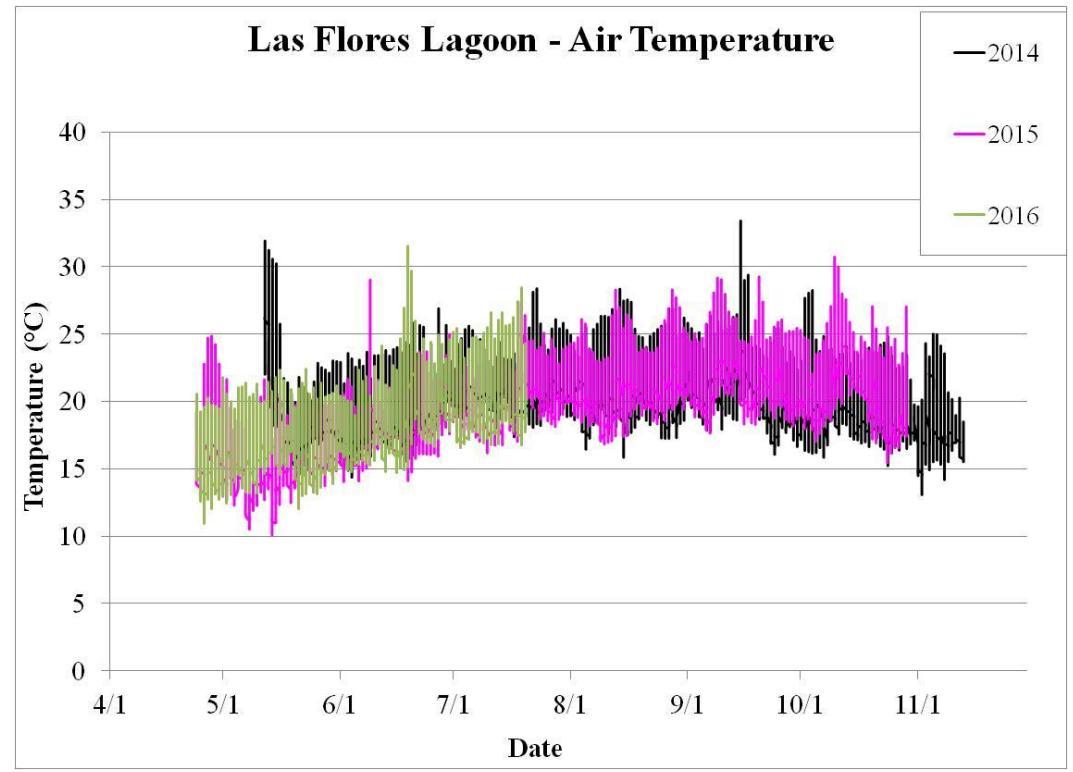
Figure 1.7. Las Flores Lagoon air temperatures from April through November of 2014- 2016.

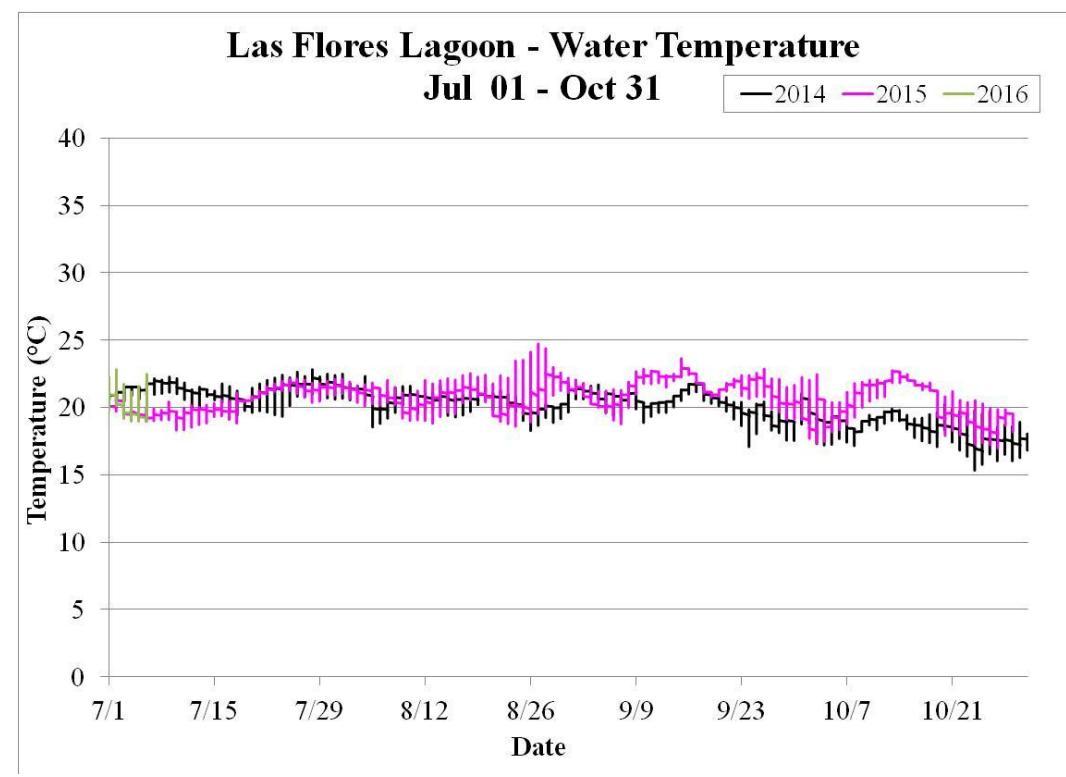
Figure 1.8. Las Flores Lagoon summer water temperatures for 2014 - 2016.

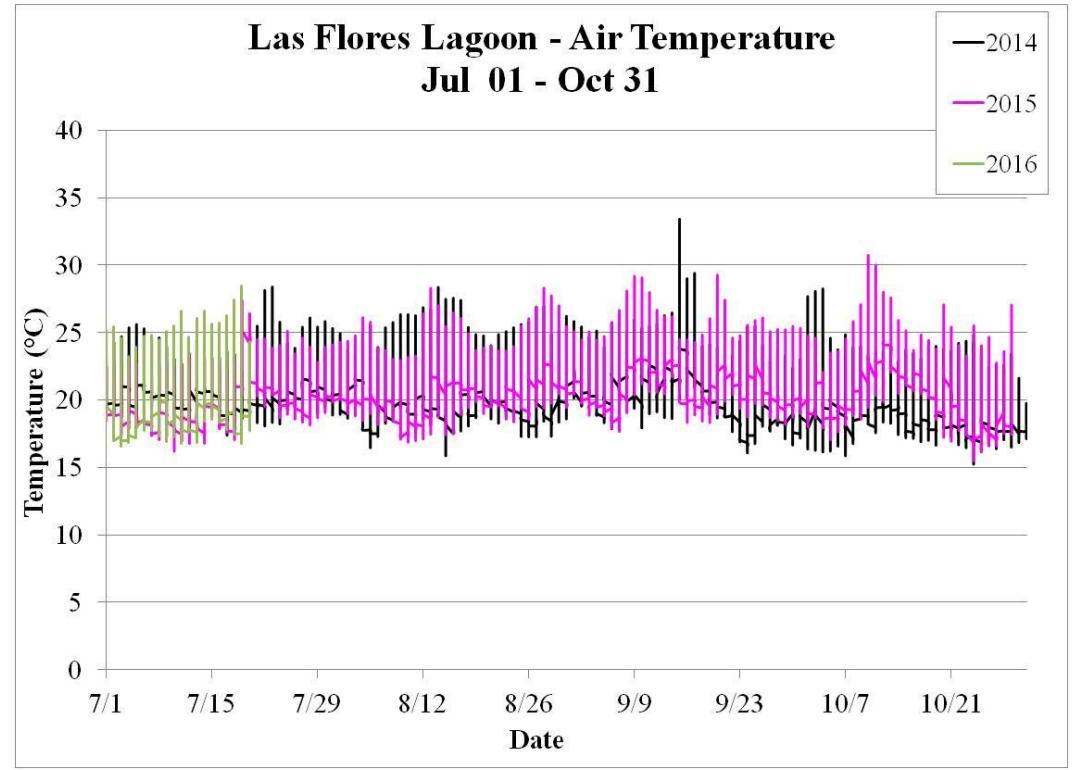
Figure 1.9. Las Flores Lagoon summer air temperatures for 2014 -2016.

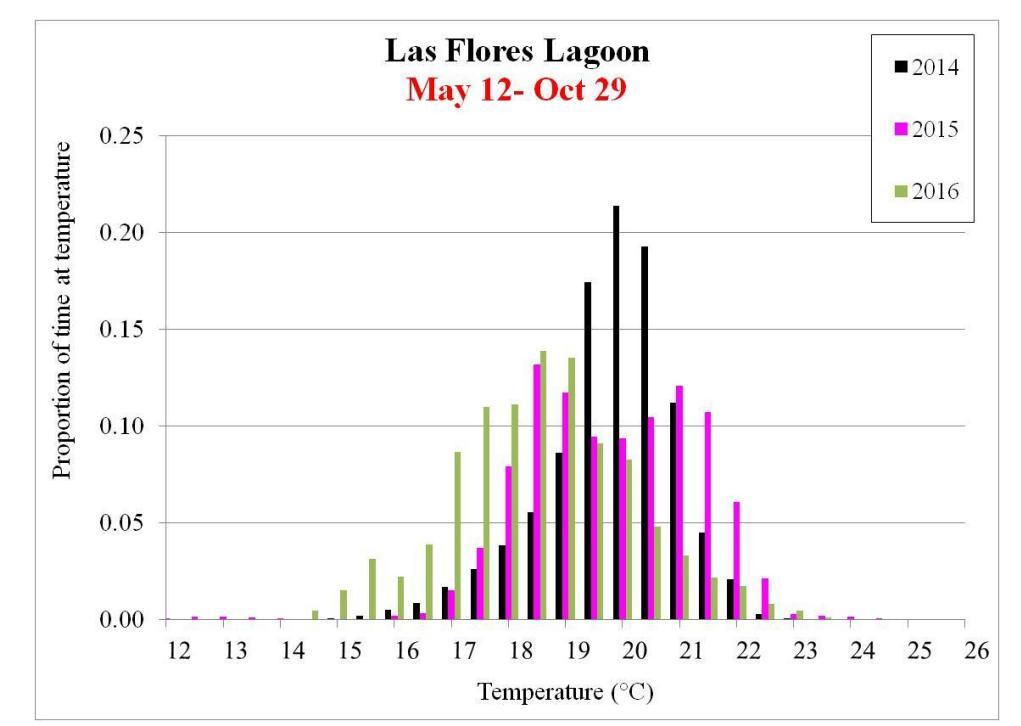
Figure 1.10. Las Flores Lagoon frequency distribution of temperatures recorded every 30 minutes from May 12-October 29, for 2014 -2016. (The period selected is based on data availability for all years)

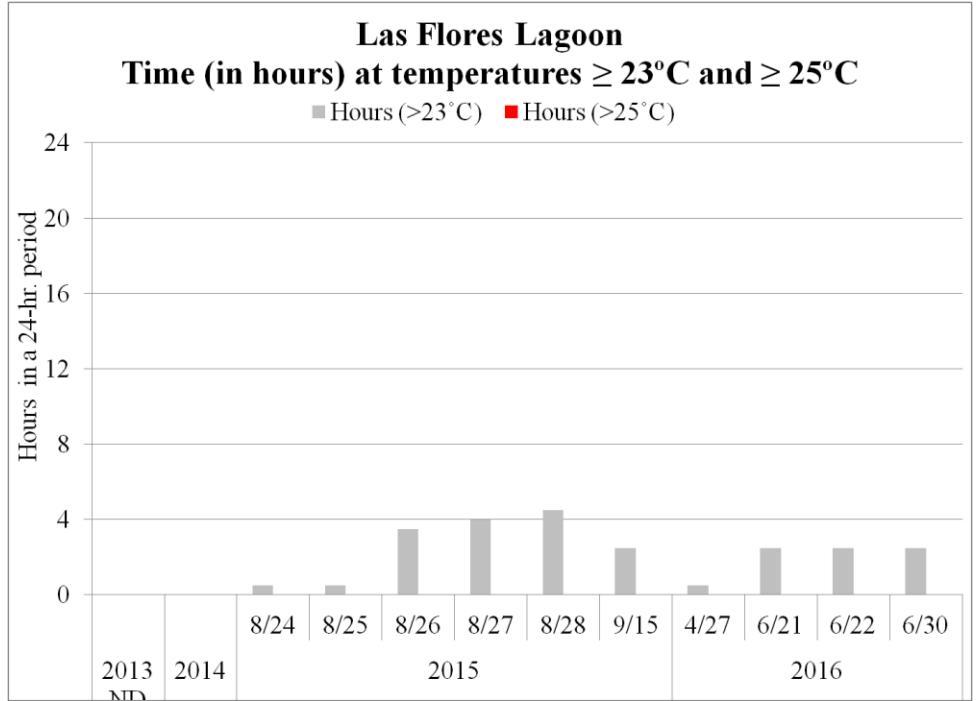
Figure 1.11. Occurrence of high temperatures and the number of hours greater than 23°C and 25°C recorded during the monitoring period for each year in Las Flores Lagoon.

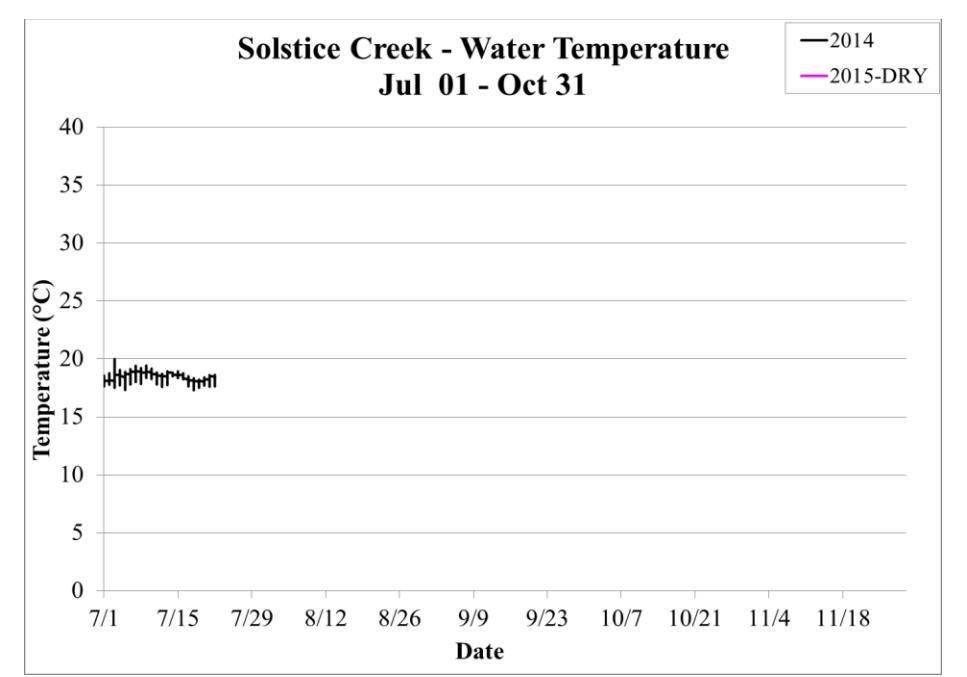
Figure 1.13. Solstice Creek - Black Widow Pool water temperatures for the monitoring period from April through November of 2014.

Continuously recording thermometers were deployed in the Black Widow pool upstream of the limit of anadromy during 2014 in order to obtain some information on refugia pool conditions and to assist NPS with their monitoring of the re-introduced red legged frogs. Although there is no possibility of *O. mykiss* using this pool, we hoped to get a sense of an upper watershed refugia pool temperature range. This small (3 m x 4 m) pool had an average depth of 45 cm but the location where the tidbit was installed went dry mid-summer. We did not deploy it again from 2015 through 2017 as flows and depth in the lagoon were even lower. Figures 1.12 through 1.14 and Table 1.8 show air and water temperatures collected during the 2014 monitoring period.

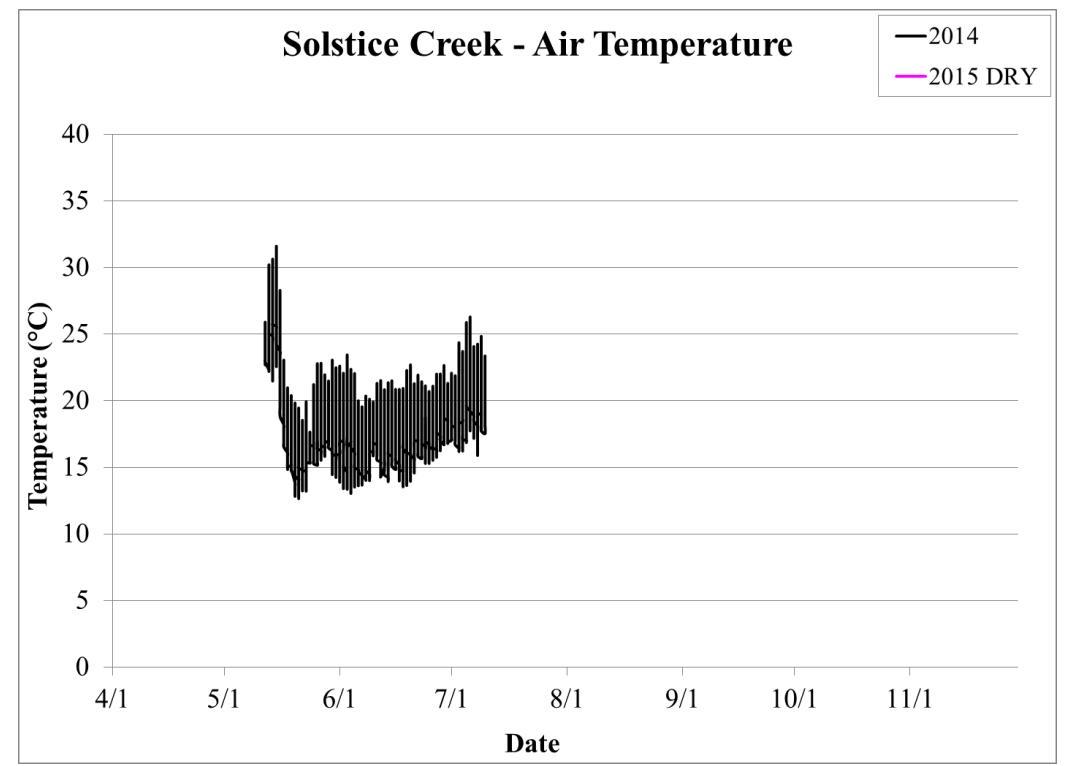
Figure 1.14. Solstice Creek - Black Widow Pool air temperatures for the monitoring period from April through November of 2015.

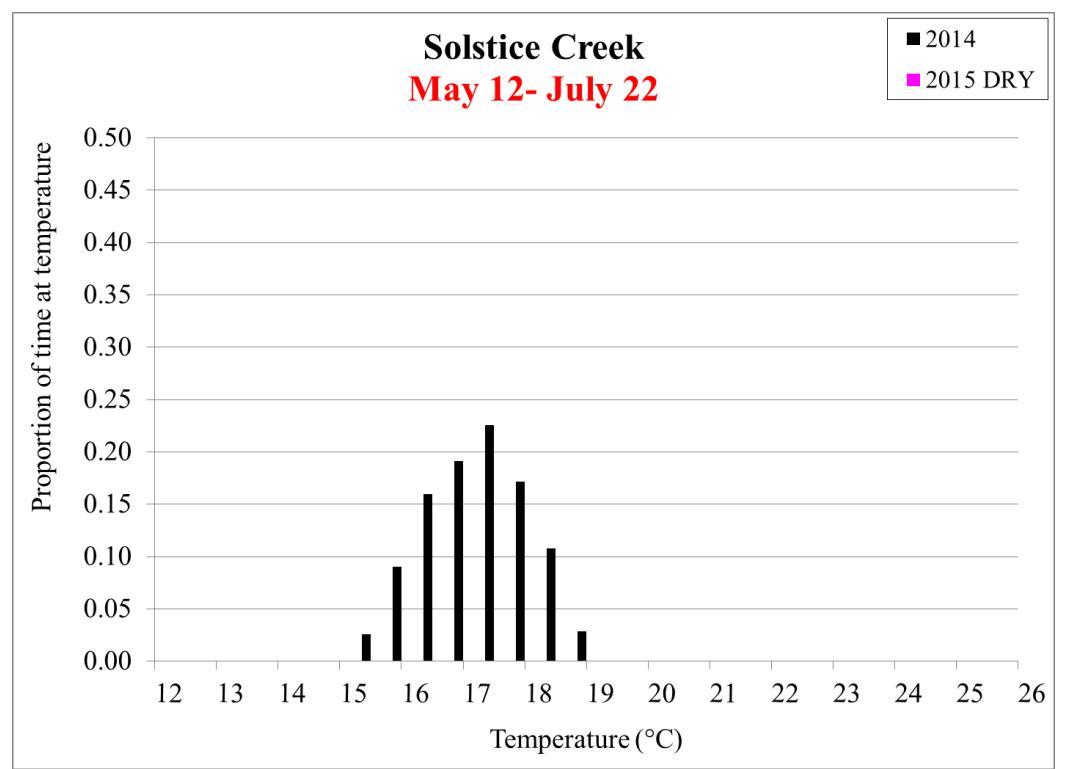
Figure 1.15. Solstice Creek - Black Widow Pool frequency distribution of temperatures recorded every 30 minutes from May 12-July 22 2014.

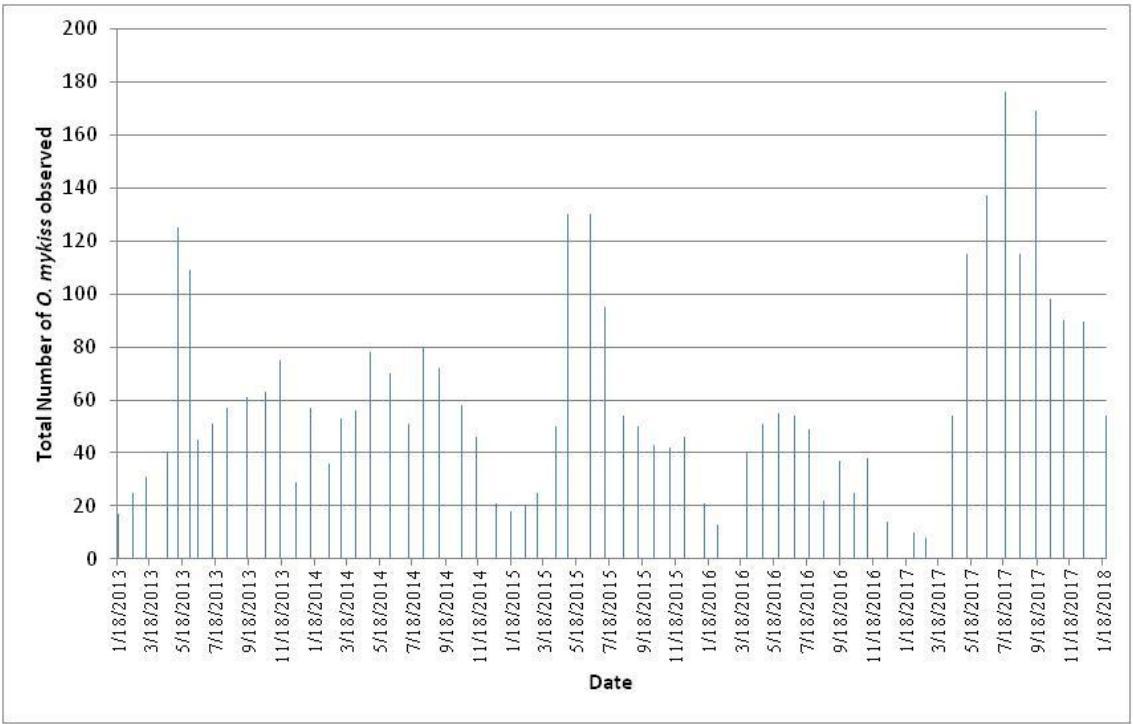
Figure 1.4. Abundance of O. mykiss in Topanga Creek 2013- March 2018

Monthly snorkel surveys documented the abundance and distribution of *O. mykiss* between the ocean and the upper limit of anadromy located at approximately 5.3 river kilometers from the ocean (Dagit et al. 2018). Figure 1.17 shows the total number of *O. mykiss* observed. The relative abundance follows a fairly normal seasonal trend reflecting young of the year appearing in the spring, and recruiting into larger size classes over the summer and fall. Winter counts are often low due to cold temperatures,, even though the fish have not been able to move out of the system.

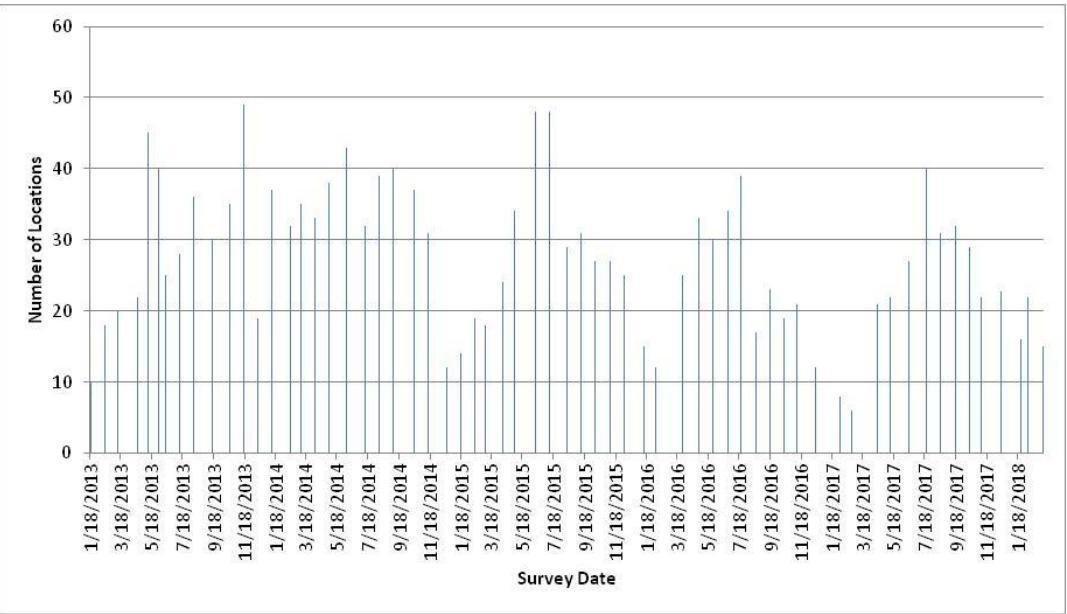
Figure 1.5. Distribution of O. mykiss in Topanga Creek 2013-March 2018

Figure 1.18 shows the number of discrete habitat unit locations where *O. mykiss* were observed. During most of the year, the fish are found in identifiable refugia pools, but distribution expands in spring when young of the year are found in shallower habitat units, and contract in the winter when fewer fish are observed overall.

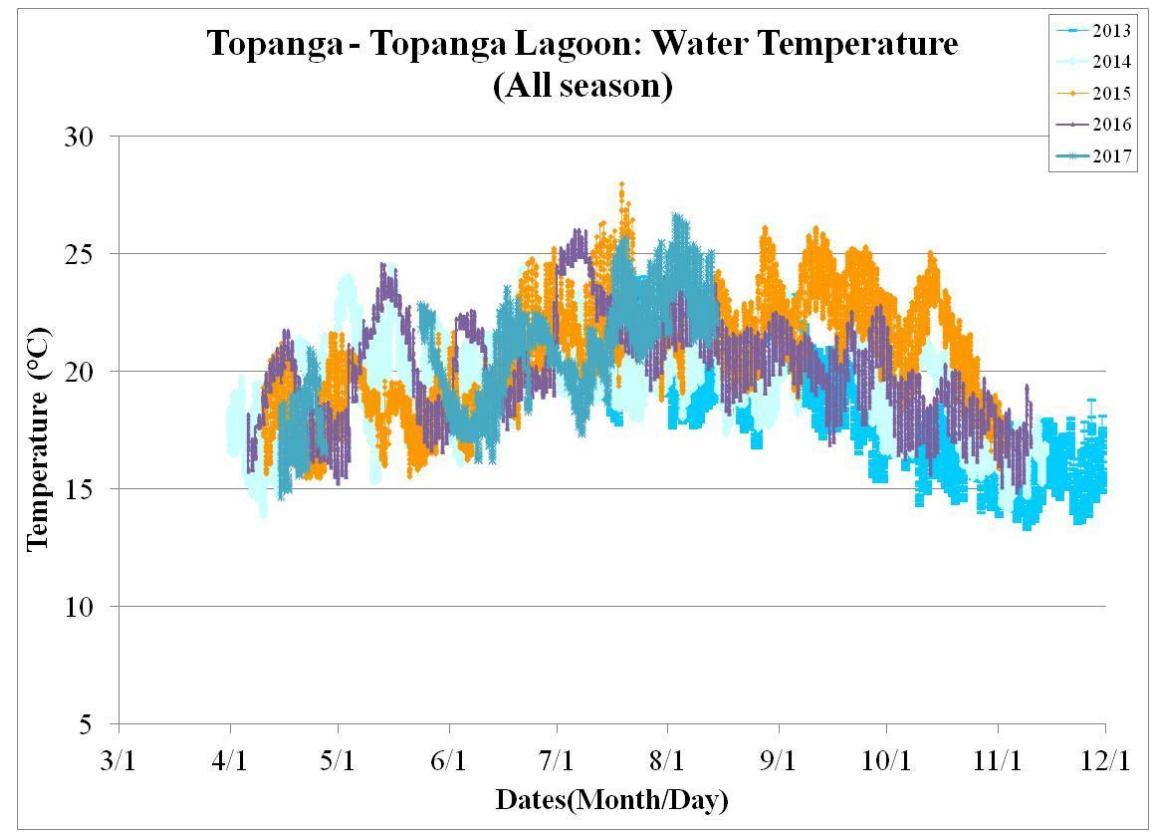
Figure 1.6. Topanga Lagoon water temperatures for monitoring period April - November of 2013 to 2017

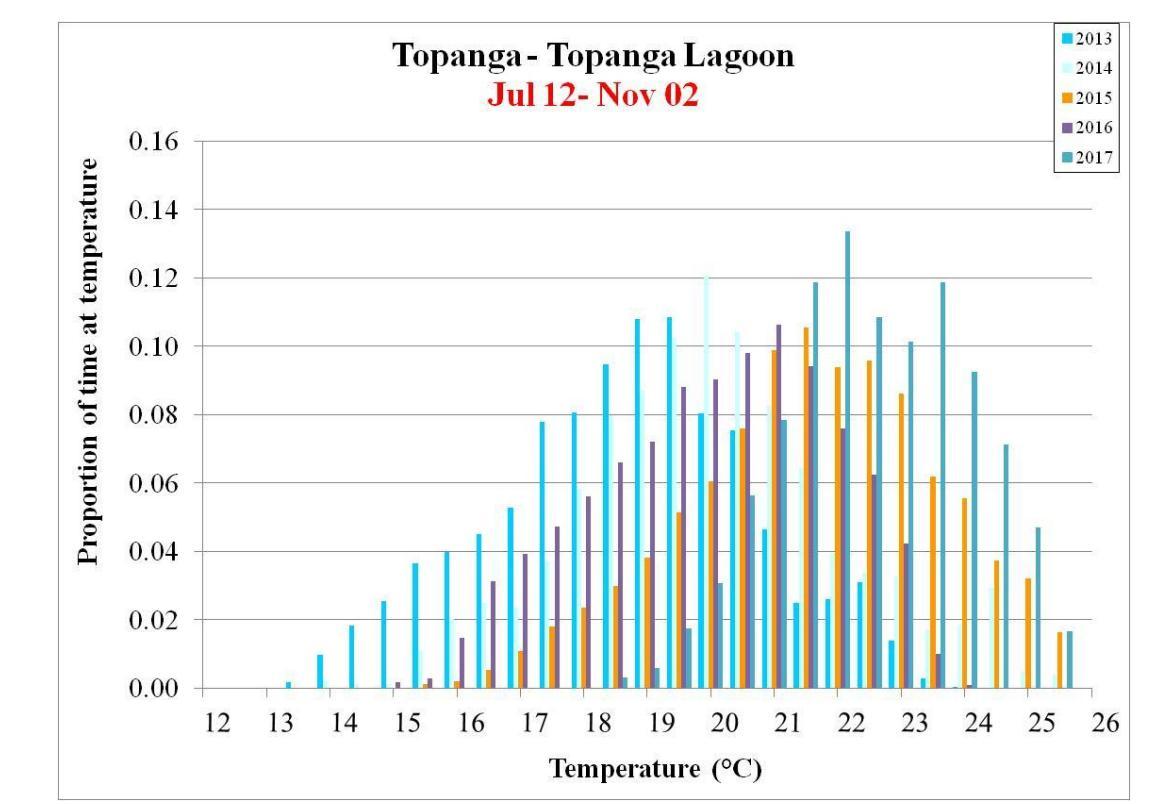
Figure 1.20. Topanga Lagoon frequency distribution of temperatures recorded every 30 minutes from Jul 12-November 02, for 2013 through 2017. (The period selected is based on data availability for all years)

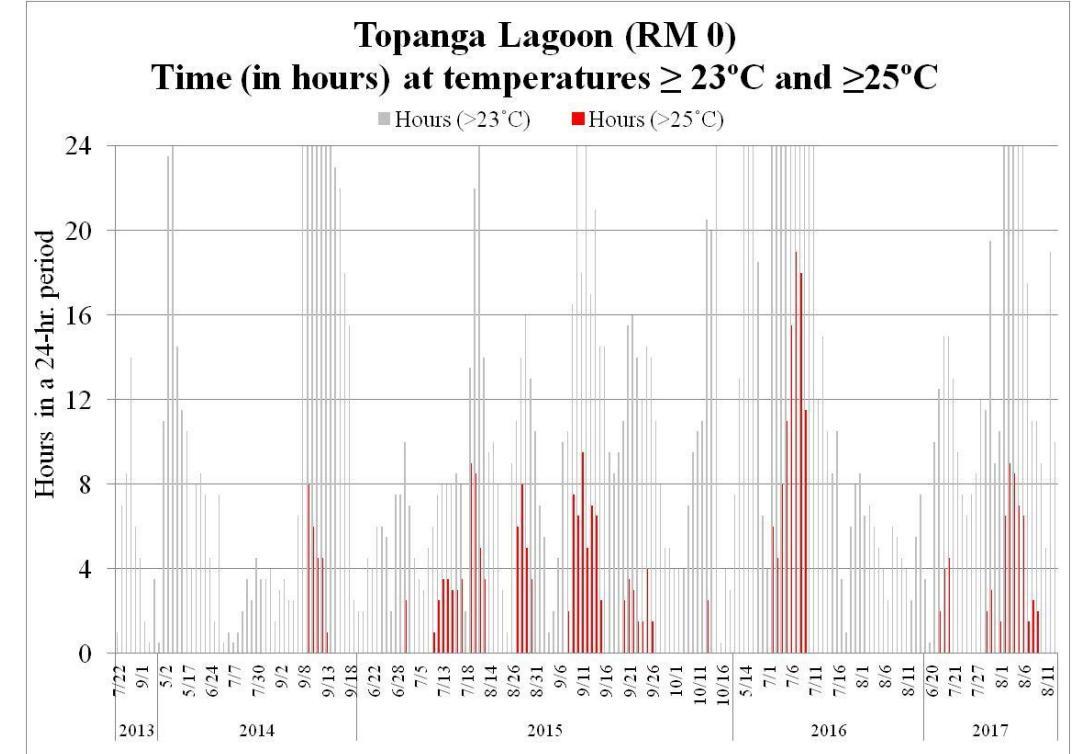
Figure 1.21. Occurrence of high temperatures and the number of hours greater than 23°C and 25°C recorded during the monitoring period for each year in Topanga Lagoon.

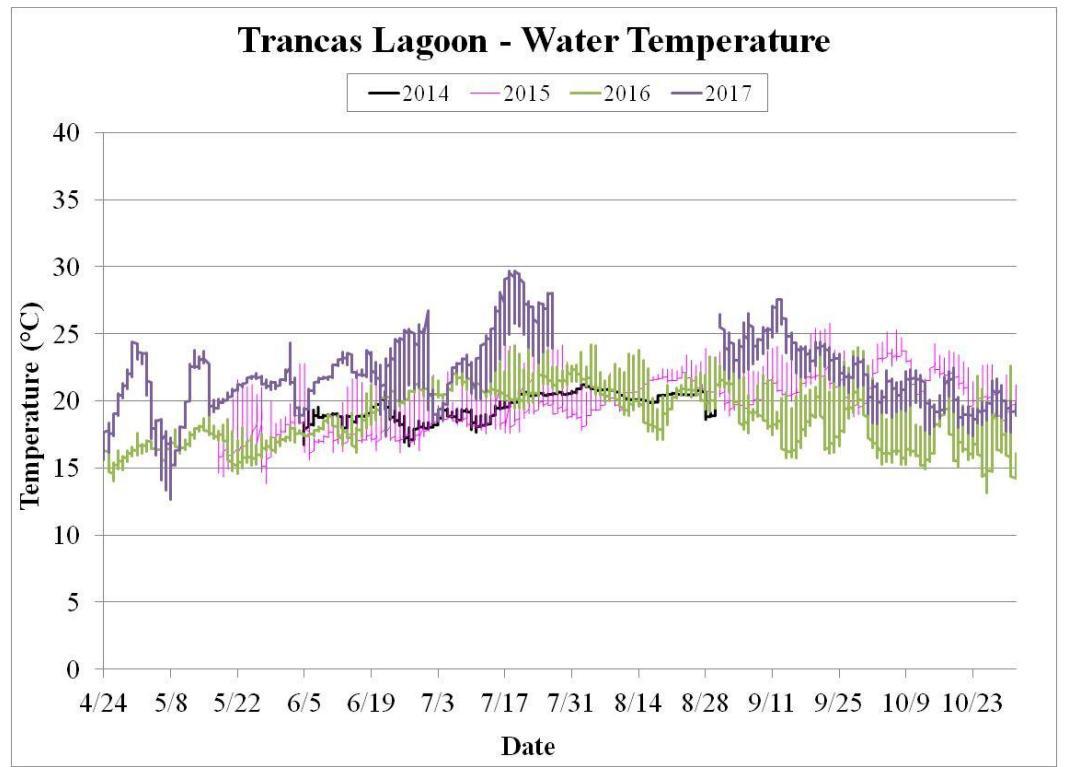
Figure 1.23. Trancas Lagoon water temperatures for the monitoring period from April through November of 2014-2017. Data for 2014 ends August 2014 due to dry up.

Figures 1.22 through 1.25 illustrate the changes in water temperature over time. As was observed in Las Flores and Topanga Creeks, the proportion of time when water temperatures were higher increased during 2015, as did the number of times water temperature exceeded 23 °C, the critical thermal limit for steelhead.

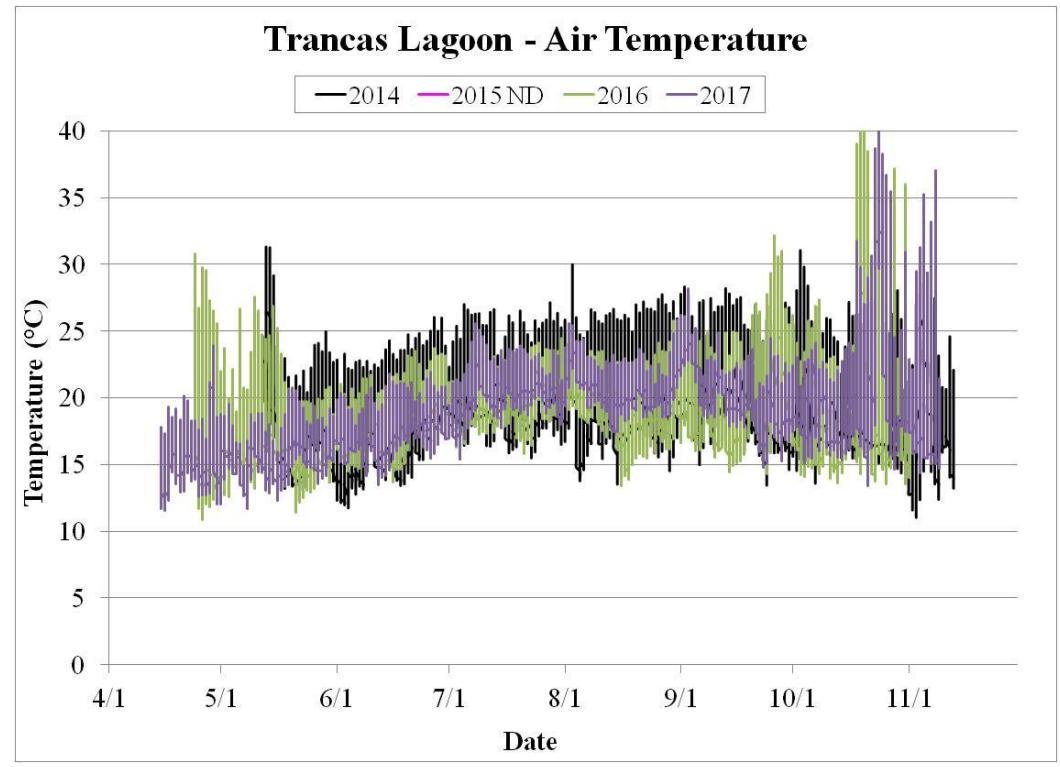
Figure 1.24. Trancas Lagoon air temperatures from April through November, 2014-2017. No air data was collected for 2015.

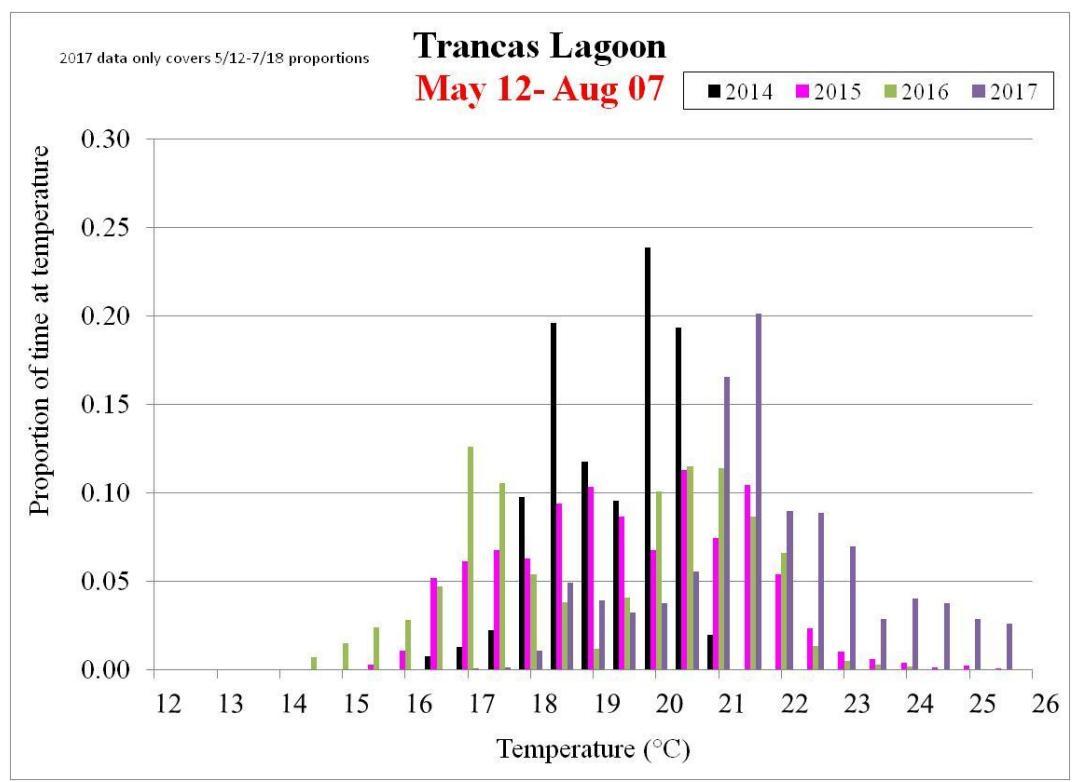
Figure 1.7. Trancas Lagoon frequency distribution of temperatures recorded every 30 minutes from May 12-August 07, for 2014-2017. (The period selected is based on data availability for all years)

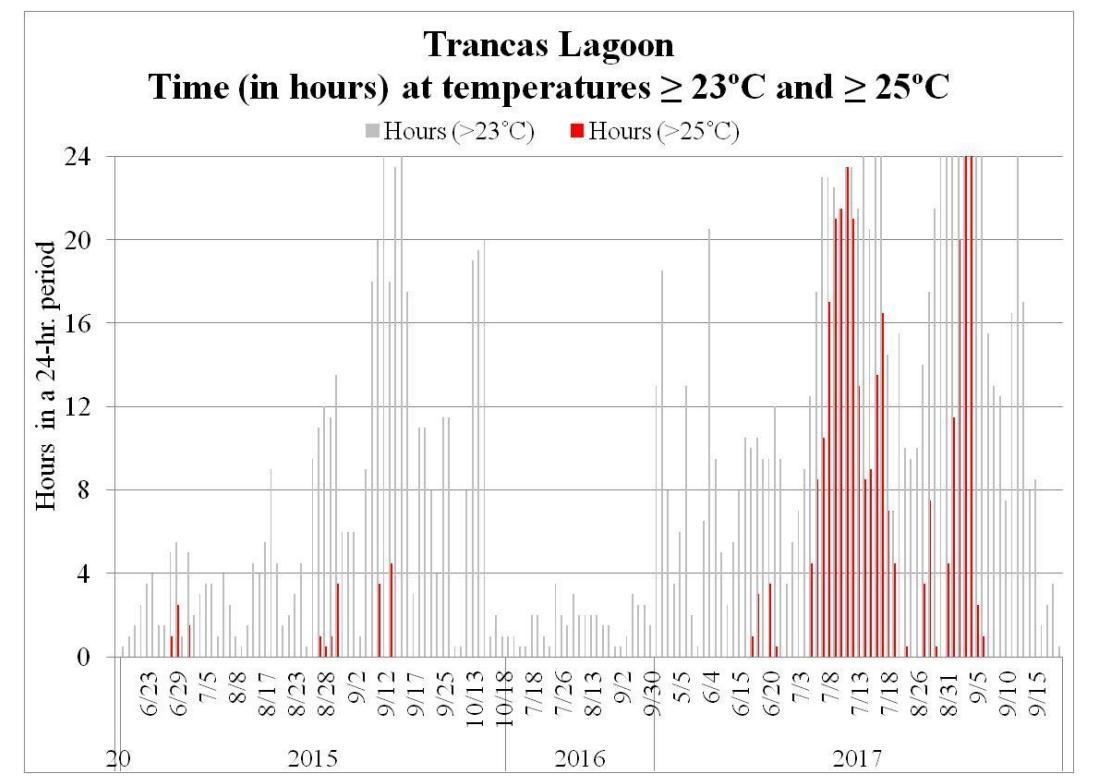
Figure 1.26. Occurrence of high temperatures and the number of hours greater than 23°C and 25°C recorded during the monitoring period for each year in Trancas Lagoon.
